**Flood Control Project Maintenance
Levee Inspections**

Maintenance Issue Types Only, Levee Inspection Report By Mile - Spring 2018

Reclamation District No. 0563 Tyler Island

Waterway	Bank	Unit Miles	Inspection Start/End	Inspector
Unit No. 01 Georgiana Slough (Tyler Island)	Left	12.11	03/30/2018 03/30/2018	Keith Millard

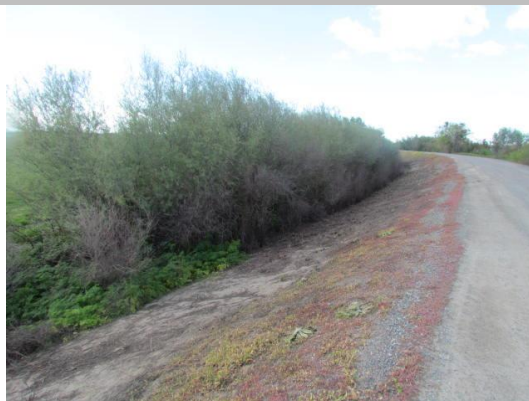
Photo 3 of 5 : SP_2018_RD0563_210_74_20180305_00057.jpg

Looking south at dense vegetation (willows) at landward toe. (Spring 2016)

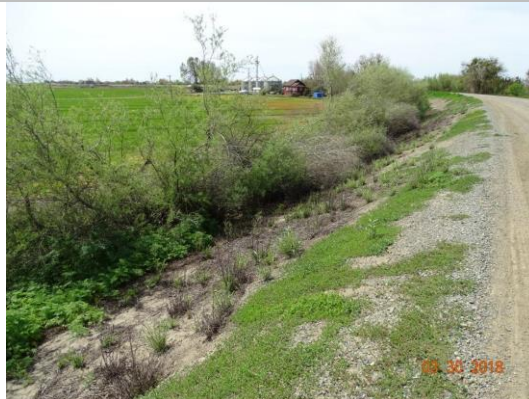
Photo 1 of 1 : SP_2018_RD0563_210_112_20180330_00241.jpg

LM Start	3.11	Rating **	U	Issue No.	112
LM End	3.18	Issue Type +	Ma	Location *	LS
Category	Earthen Levee			GPS Latitude/Longitude	
				Start	End
Item	Vegetation			38.210018 °	38.209495 °
				-121.538353 °	-121.539515 °
DWR ID	DWR_RD0563_01_s_2018_112				
Comment Code					
V7 : Trees / Woody Vegetation					
Inspector Comment					
Dense woody vegetation (up to 6" in diameter) along lower slope and toe prevents inspection and access. Needs to be removed.

Very dense woody vegetation preventing inspection and access to landside toe.

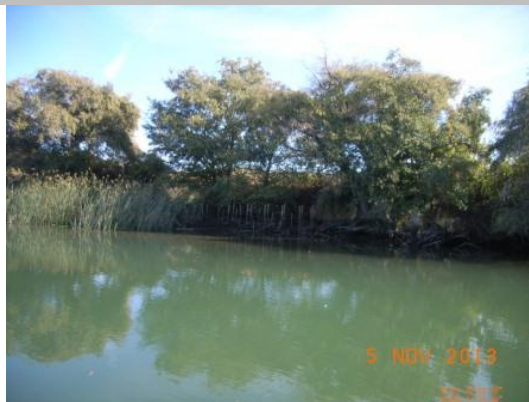
Photo 1 of 1 : SP_2018_RD0563_210_46_20180305_00034.jpg

LM Start	5.15	Rating **	U	Issue No.	46
LM End	5.39	Issue Type +	Ma	Location *	WS
Category	Supplemental			GPS Latitude/Longitude	
				Start	End
Item	2015 USACE Erosion Survey, DRAFT			38.188216 °	38.185968 °
				-121.558442 °	-121.561667 °
DWR ID	DWR_RD0563_01_s_2016_46				
Comment Code					
Inspector Comment					
1997 - Deep pockets of erosion into a narrow berm just downstream of the rock. 2000 - Scallops in banks with small colored flags, some new biotech rolls in with older rolls in the scallops. 2001 - Staked , low fascine walls at the bankline. 2011 - Site upgraded to CRITICAL. Site extended upstream due to new erosion pocket. New tree popouts and new erosion. 2013 - Pipe observed at upstream end of site. 2015: Last observed in 2013. [2015 Site ID: GEO_6-8_L]

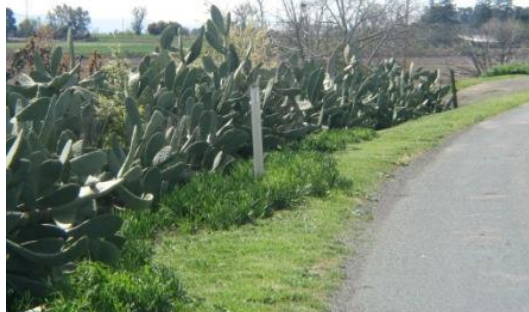
Photo 1 of 2 : SP_2018_RD0563_210_22_20180305_00013.jpg

LM Start	5.92	Rating **	U	Issue No.	22
LM End	5.96	Issue Type +	Ma	Location *	LS
Category	Earthen Levee			GPS Latitude/Longitude	
				Start	End
Item	Vegetation			38.181965 °	38.181763 °
				-121.569913 °	-121.570447 °
DWR ID	DWR_RD0563_01_s_2012_22				
Comment Code					
V2 : Remove the wild growth other than native grasses from the levee slopes.					
Inspector Comment					
Large cactus on landside slope.

Large cactus plant on landward slope from LM 6.04 to 6.08

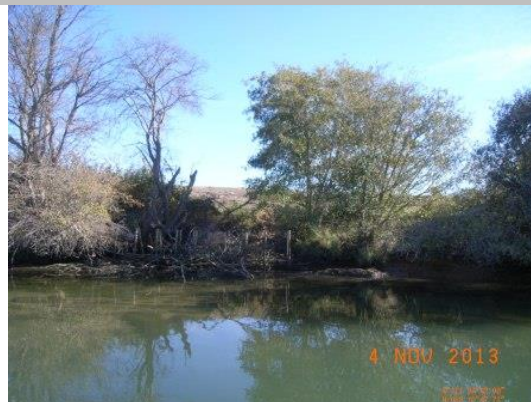
Photo 1 of 1 : SP_2018_RD0563_210_44_20180305_00032.jpg

LM Start	6.38	Rating **	M	Issue No.	44
LM End	6.46	Issue Type +	Ma	Location *	WS
Category	Supplemental			GPS Latitude/Longitude	
				Start	End
Item	2015 USACE Erosion Survey, DRAFT			38.180462 °	38.179319 °
				-121.577895 °	-121.578566 °
DWR ID	DWR_RD0563_01_s_2016_44				
Comment Code					
Inspector Comment					
2013 - Erosion pockets into the levee prism. Erosion pockets primarily located behind unmaintained brush boxes. 2015: Last observed in 2013. [2015 Site ID: GEO_5-8_L]

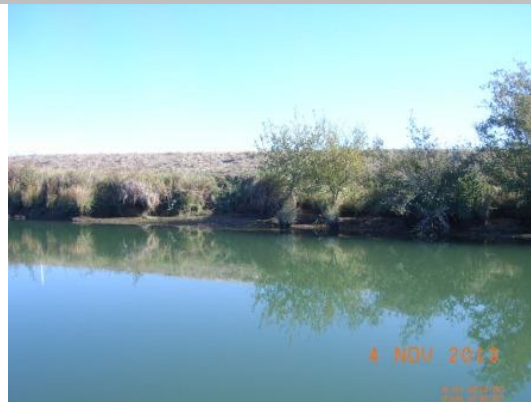
Photo 1 of 1 : SP_2018_RD0563_210_51_20180305_00038.jpg

LM Start	6.64	Rating **	M	Issue No.	51
LM End	7.28	Issue Type +	Ma	Location *	WS
Category	Supplemental			GPS Latitude/Longitude	
				Start	End
Item	2015 USACE Erosion Survey, DRAFT			38.176861 °	38.167959 °
				-121.579747 °	-121.581616 °
DWR ID	DWR_RD0563_01_s_2016_51				
Comment Code					
Inspector Comment					
1997 - Pocket erosion into the toe of the levee. 2000 - Scallops in banks with small colored flags, biotech rolls present. 2001 - Staked, low fascine walls at bankline. 2003 - Still have visibly bad spots, especially at the upstream end. 2005 - Some new brush bundles in the brush boxes; some with missing bundles. Some boxes too low relative to high tide. 2010 - Site extended upstream. 2011 - Minor new erosion. 2015: Last observed in 2013. [2015 Site ID: GEO_5-3_L]

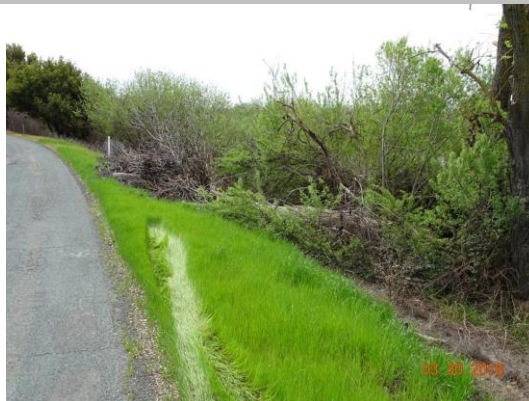
Photo 1 of 1 : SP_2018_RD0563_210_93_20180330_00244.jpg

LM Start	6.74	Rating **	U	Issue No.	93
LM End	6.74	Issue Type +	Ma	Location *	WS
Category	Earthen Levee			GPS Latitude/Longitude	
				Start	End
Item	Encroachments			38.175352 °	38.175352 °
				-121.580177 °	-121.580177 °
DWR ID	DWR_RD0563_01_s_2018_93				
Comment Code					
TR : Tree or limb					
Inspector Comment					
Large fallen tree should be removed from waterside slope and shoulder.

Remove fallen tree from levee slope.

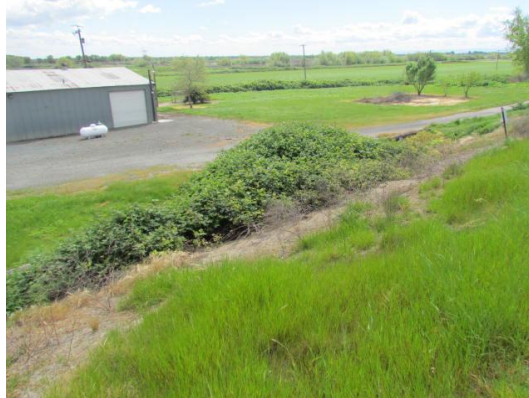
Photo 1 of 1 : SP_2018_RD0563_210_151_20180305_00126.jpg

LM Start	7.07	Rating **	U	Issue No.	151
LM End	7.07	Issue Type +	Ma	Location *	LS
Category	Earthen Levee			GPS Latitude/Longitude	
				Start	End
Item	Vegetation			38.170693 °	38.170693 °
				-121.579968 °	-121.579968 °
DWR ID	DWR_RD0563_01_f_2014_151				
Comment Code					
V2 : Remove the wild growth other than native grasses from the levee slopes.					
Inspector Comment					
Dense berryvines at landside toe.

Looking southeast at dense vegetation at landward toe.

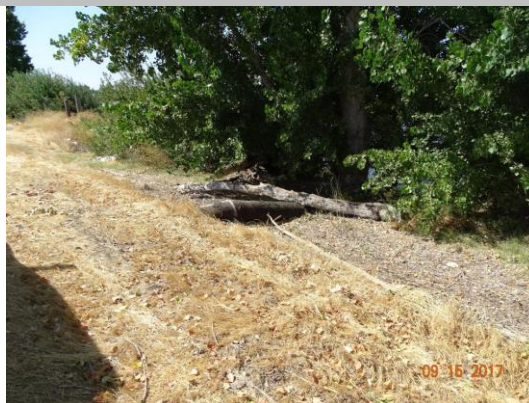
Photo 1 of 1 : SP_2018_RD0563_210_117_20180305_00097.jpg

LM Start	7.36	Rating **	M	Issue No.	117
LM End	7.36	Issue Type +	Ma	Location *	WS
Category	Earthen Levee			GPS Latitude/Longitude	
				Start	End
Item	Encroachments			38.166856 °	38.166856 °
				-121.582091 °	-121.582091 °
DWR ID	DWR_RD0563_01_f_2017_117				
Comment Code					
TR : Tree or limb					
Inspector Comment

Looking southwest at the waterside slope.

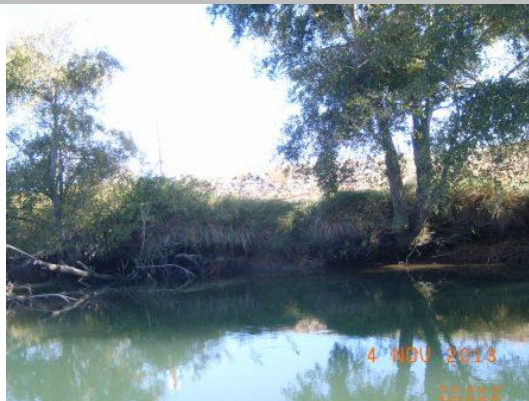
Photo 1 of 1 : SP_2018_RD0563_210_53_20180305_00039.jpg

LM Start	7.53	Rating **	U	Issue No.	53
LM End	7.80	Issue Type +	Ma	Location *	WS
Category	Supplemental			GPS Latitude/Longitude	
				Start	End
Item	2015 USACE Erosion Survey, DRAFT			38.164462 °	38.160888 °
				-121.583092 °	-121.584807 °
DWR ID	DWR_RD0563_01_s_2016_53				
Comment Code					
Inspector Comment					
1997 - Pocket erosion at upstream end and into the levee toe under the Alder trees. 2003 - New brush boxes with wattles on bank. 2004 - No brush boxes. 2005 - Site extended from the downstream side of the bridge. Whole bank is vertical. 2010 - Some minor new erosion. 2011 - Site upgraded to CRITICAL. New erosion pockets throughout the site. Sites 4.5, and 4.6 were combined. 2015: Last observed in 2013. [2015 Site ID: GEO_4-5_L]

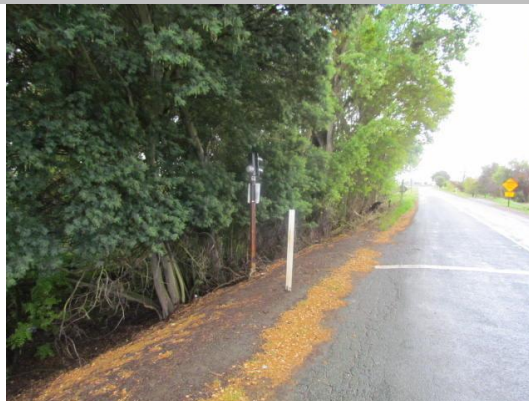
Photo 1 of 1 : SP_2018_RD0563_210_29_20180305_00021.jpg

LM Start	7.74	Rating **	M	Issue No.	29
LM End	7.78	Issue Type +	Ma	Location *	LS
Category	Earthen Levee			GPS Latitude/Longitude	
				Start	End
Item	Trim / Thin Trees			38.161607 °	38.161092 °
				-121.584258 °	-121.584470 °
DWR ID	DWR_RD0563_01_s _ 2012_29				
Comment Code					
T1 : Trim trees to at least five feet above ground level.					
Inspector Comment					
Dense (untrimmed) trees on landside slope. Branches on ground should also be removed.

Looking southeast at dense trees on landward slope and toe.

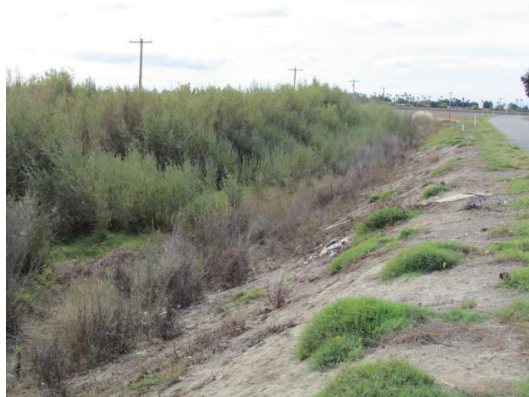
Photo 3 of 5 : SP_2018_RD0563_210_90_20180305_00077.jpg

LM Start	7.80	Rating **	U	Issue No.	90
LM End	7.94	Issue Type +	Ma	Location *	LS
Category	Earthen Levee			GPS Latitude/Longitude	
				Start	End
Item	Vegetation			38.160800 °	38.158922 °
				-121.584598 °	-121.585433 °
DWR ID	DWR_RD0563_01_s _ 2012_90				
Comment Code					
V2 : Remove the wild growth other than native grasses from the levee slopes.					
Inspector Comment					
Berryvines and willows on landside toe.

Looking south at dense vegetation on landside toe. (2012 Fall Inspection)

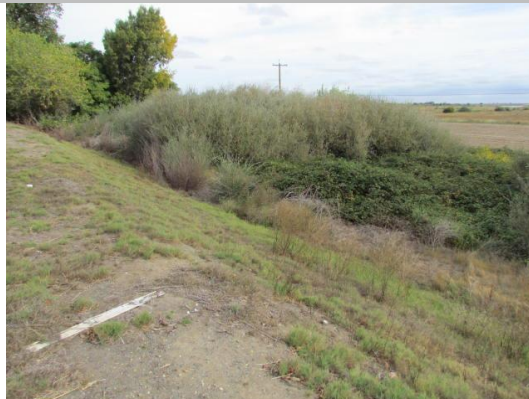
Photo 4 of 5 : SP_2018_RD0563_210_90_20180305_00078.jpg

Looking northeast at dense vegetation on landside toe. (2012 Fall Inspection)

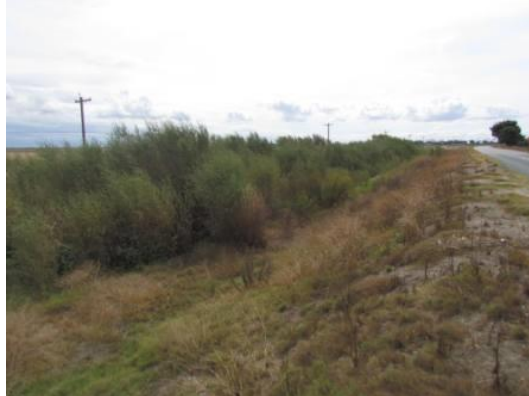
Photo 5 of 5 : SP_2018_RD0563_210_90_20180305_00079.jpg

Looking southwest at dense vegetation on landside toe.

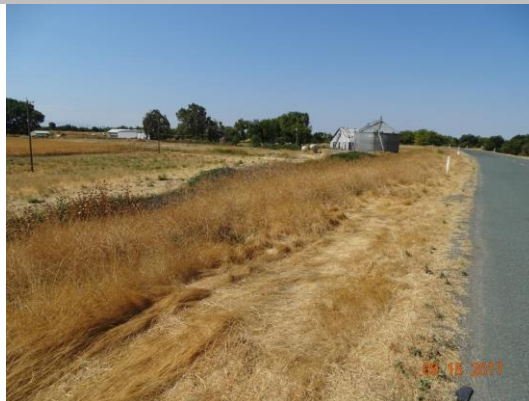
Photo 1 of 3 : SP_2018_RD0563_210_767_20180305_00138.jpg

LM Start	8.18	Rating **	U	Issue No.	767
LM End	8.22	Issue Type +	Ma	Location *	LS
Category	Earthen Levee			GPS Latitude/Longitude	
				Start	End
Item	Vegetation			38.156878 °	38.156945 °
				-121.588505 °	-121.589258 °
DWR ID	DWR_RD0563_01_s_2015_767				
Comment Code					
V2 : Remove the wild growth other than native grasses from the levee slopes.					
Inspector Comment					
Dead dense vegetation blocking landside toe.

Looking south at the landside slope.

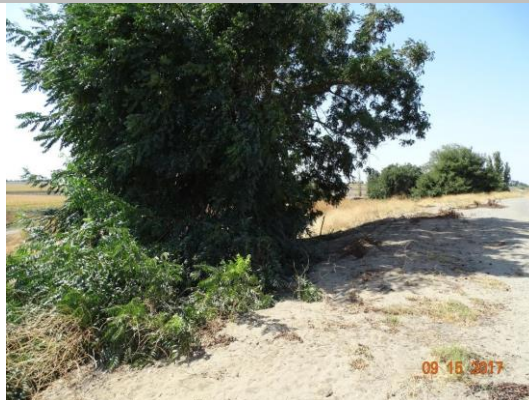
Photo 1 of 2 : SP_2018_RD0563_210_768_20180305_00141.jpg

LM Start	9.25	Rating **	M	Issue No.	768
LM End	9.25	Issue Type +	Ma	Location *	LS
Category	Earthen Levee			GPS Latitude/Longitude	
				Start	End
Item	Trim / Thin Trees			38.145897 °	38.145897 °
				-121.588203 °	-121.588203 °
DWR ID	DWR_RD0563_01_s_2015_768				
Comment Code					
T1 : Trim trees to at least five feet above ground level.					
Inspector Comment

Looking south at the landside slope.

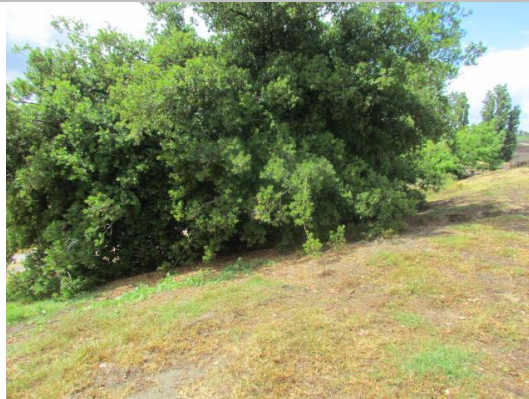
Photo 1 of 1 : SP_2018_RD0563_210_98_20180305_00083.jpg

LM Start	9.28	Rating **	U	Issue No.	98
LM End	9.28	Issue Type +	Ma	Location *	LS
Category	Earthen Levee			GPS Latitude/Longitude	
				Start	End
Item	Trim / Thin Trees			38.145825 °	38.145825 °
				-121.588807 °	-121.588807 °
DWR ID	DWR_RD0563_01_s_2013_98				
Comment Code					
T1 : Trim trees to at least five feet above ground level.					
Inspector Comment

Looking southeast at untrimmed trees on landward slope.

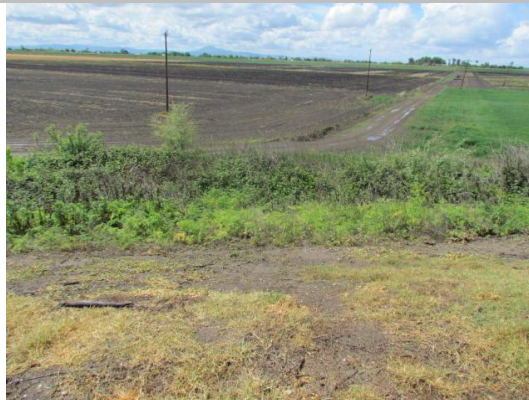
Photo 1 of 1 : SP_2018_RD0563_210_769_20180305_00143.jpg

LM Start	9.36	Rating **	M	Issue No.	769
LM End	9.43	Issue Type +	Ma	Location *	LS
Category	Earthen Levee			GPS Latitude/Longitude	
				Start	End
Item	Vegetation			38.146276 °	38.147034 °
				-121.590189 °	-121.590907 °
DWR ID	DWR_RD0563_01_s_2015_769				
Comment Code					
V2 : Remove the wild growth other than native grasses from the levee slopes.					
Inspector Comment

Looking east at dense vegetation at landward toe. (Spring 2015)

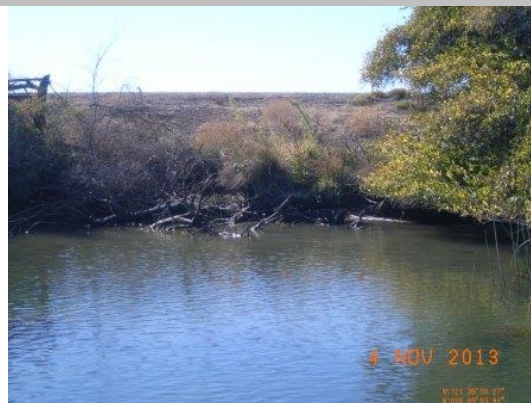
Photo 1 of 1 : SP_2018_RD0563_210_41_20180305_00029.jpg

LM Start	9.73	Rating **	A/W	Issue No.	41
LM End	9.90	Issue Type +	Ma	Location *	WS
Category	Supplemental			GPS Latitude/Longitude	
				Start	End
Item	2015 USACE Erosion Survey, DRAFT			38.150820 °	38.150647 °
				-121.593650 °	-121.596858 °
DWR ID	DWR_RD0563_01_s_2016_41				
Comment Code					
Inspector Comment					
1997 - Erosion pockets into the toe of the levee. 2001 - Staked low fascine walls at the bankline. 2004 - Numerous "Brush Boxes." 2005 - Some new bundles in the brush boxes. 2012 - Site extended downstream to account for new bank sloughing. 2013 - Some rock added to the upstream end by the local RD. 2015: Last observed in 2013. [2015 Site ID: GEO_2-5_L]

USACE 2013 Photo #1

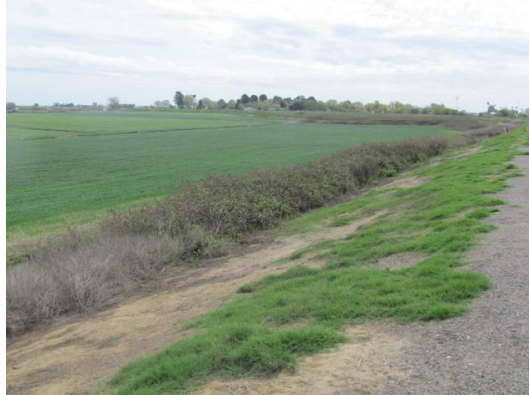
Photo 2 of 3 : SP_2018_RD0563_210_100_20180305_00087.jpg

LM Start	10.67	Rating **	U	Issue No.	100 (cont)	
LM End	10.81	Issue Type +	Ma	Location *	LS	
Category	Earthen Levee			GPS Latitude/Longitude		
				Start		End
Item	Vegetation			38.140886 °		38.139079 °
				-121.597280 °		-121.596214 °
DWR ID	DWR_RD0563_01_s_2013_100					
Comment Code						
V2 : Remove the wild growth other than native grasses from the levee slopes.						
Inspector Comment						
Wild rose or grape vines on landside slope and toe.

Looking south at dense vegetation at landward toe. (Fall 2014)

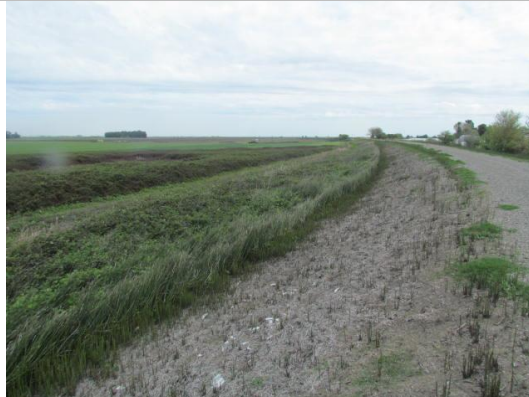
Photo 3 of 3 : SP_2018_RD0563_210_100_20180305_00088.jpg

LM Start	10.67	Rating **	U	Issue No.	100 (cont)
LM End	10.81	Issue Type +	Ma	Location *	LS

Looking south at additional dense vegetation at landward toe.

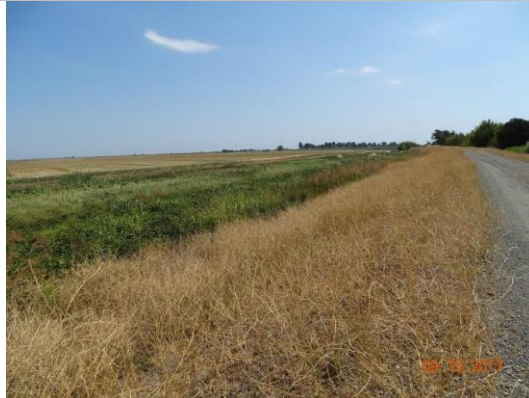
Photo 1 of 3 : SP_2018_RD0563_210_770_20180305_00144.jpg

LM Start	11.01	Rating **	U	Issue No.	770
LM End	12.00	Issue Type +	Ma	Location *	LS
Category	Earthen Levee			GPS Latitude/Longitude	
				Start	End
Item	Vegetation			38.136623 °	38.130739 °
				-121.594216 °	-121.579678 °
DWR ID	DWR_RD0563_01_s_2015_770				
Comment Code					
V2 : Remove the wild growth other than native grasses from the levee slopes.					
Inspector Comment					
Dense veg (wildroses) at landside toe.

Looking southeast at the landside slope.

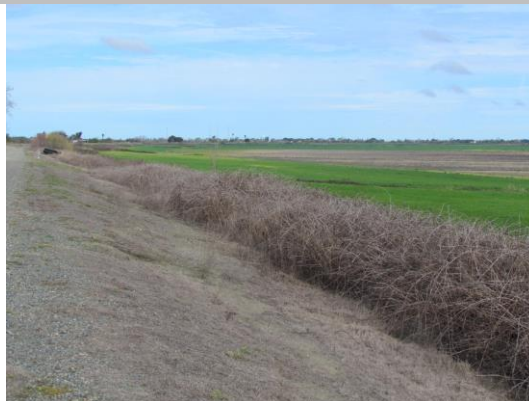
Photo 2 of 3 : SP_2018_RD0563_210_770_20180305_00145.jpg

LM Start	11.01	Rating **	U	Issue No.	770 (cont)	
LM End	12.00	Issue Type +	Ma	Location *	LS	
Category	Earthen Levee			GPS Latitude/Longitude		
				Start		End
Item	Vegetation			38.136623 °		38.130739 °
				-121.594216 °		-121.579678 °
DWR ID	DWR_RD0563_01_s_2015_770					
Comment Code						
V2 : Remove the wild growth other than native grasses from the levee slopes.						
Inspector Comment						
Dense veg (wildroses) at landside toe.

Looking northeast at dead vines at landward toe. (Spring 2017)

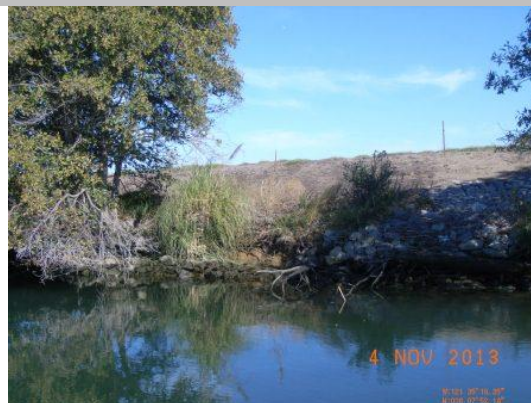
Photo 1 of 1 : SP_2018_RD0563_210_42_20180305_00030.jpg

Comment Code					
Inspector Comment					
1997 - Erosion pockets into the levee toe. 1999 - Some small pockets fixed with rock riprap. 2002 - New "brush boxes" along the bank toe. 2005 - Brush boxes are empty. Some pockets are filled with new stone. 2006 - Some new rock at the downstream end (~100 ft long). Several small pockets of new rock in scallops. Brush boxes in poor to fair condition. 2010 - Site looks a little worse, some toe rock but still has erosion scars at lower to mid slope. 2011 - Site upgraded to CRITICAL. Significant new erosion. Erosion scallops are vertical and almost the height of the levee. 2012 - Rock has been placed in some of the erosion scallops and therefore the site is no longer critical. 2013 - Site shortened site. The downstream half of site was repaired by RD. Pipe no longer in site limits. 2015: Last observed in 2013. [2015 Site ID: GEO_0-3_L]

USACE 2013 Photo #1

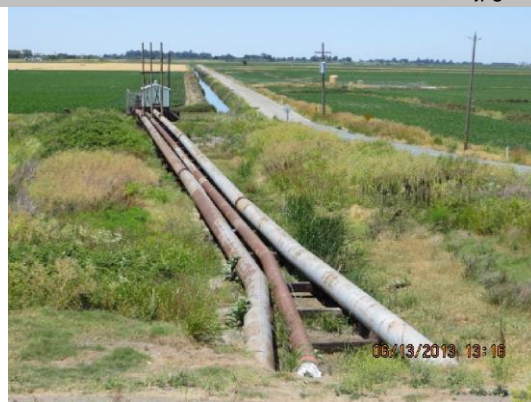
Photo 1 of 3 : UCIP_SP_2018_15027_24731.jpg

LM Start	12.00	Rating **	A/W	Issue No.	804
LM End	12.00	Issue Type +	Ma	Location *	
Category	Supplemental			GPS Latitude/Longitude	
				Start	End
Item	DWR UCIP LMA Responsibility			38.130726 °	38.130726 °
				-121.579646 °	-121.579646 °
DWR ID					
Comment Code					
Inspector Comment					
FS_ID:15027 DS_ID:20172 EP_NO: 11213 Repair Type: No Action Needed Crossing Status: Found UCIP Comments: FIELD_STRUCT_DESC: 20-inch steel drainage pipe through the levee, 1 foot below the crown. Pump on the landside (LS). Siphon breaker on the waterside (WS) shoulder. (18-inch pipe [HLM 12.28] at a depth of 4-feet authorized under Automatic Board Order (ABO) issued as Permit No. 11213, 1975 - Reclamation District No. 563). [Additional Reference(s): DWR Levee Log, 2005. USACE Sacramento O&M Manual 103, June 1954, (Station ""L "" 6+48.9)]. FS Date: 6/13/2013

Pump and pipes off LS toe.

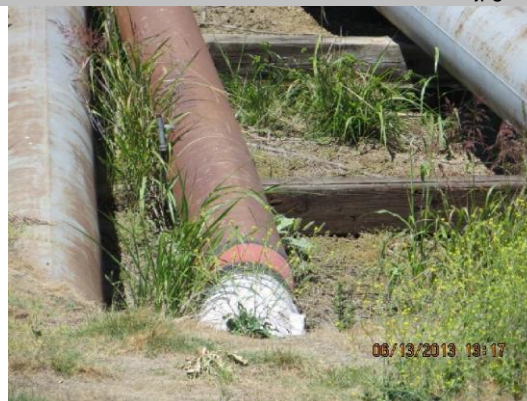
Photo 2 of 3 : UCIP_SP_2018_15027_24730.jpg

LM Start	12.00	Rating **	A/W	Issue No.	804 (cont)	
LM End	12.00	Issue Type +	Ma	Location *		
Category	Supplemental			GPS Latitude/Longitude		
				Start		End
Item	DWR UCIP LMA Responsibility			38.130726 °	38.130726 °	
				-121.579646 °	-121.579646 °	
DWR ID						
Comment Code						
Inspector Comment						
FS_ID:15027 DS_ID:20172 EP_NO: 11213 Repair Type: No Action Needed Crossing Status: Found UCIP Comments: FIELD_STRUCT_DESC: 20-inch steel drainage pipe through the levee, 1 foot below the crown. Pump on the landside (LS). Siphon breaker on the waterside (WS) shoulder. (18-inch pipe [HLM 12.28] at a depth of 4-feet authorized under Automatic Board Order (ABO) issued as Permit No. 11213, 1975 - Reclamation District No. 563). [Additional Reference(s): DWR Levee Log, 2005. USACE Sacramento O&M Manual 103, June 1954, (Station "'L"' 6+48.9)]. FS Date: 6/13/2013

20-inch pipe on LS toe.

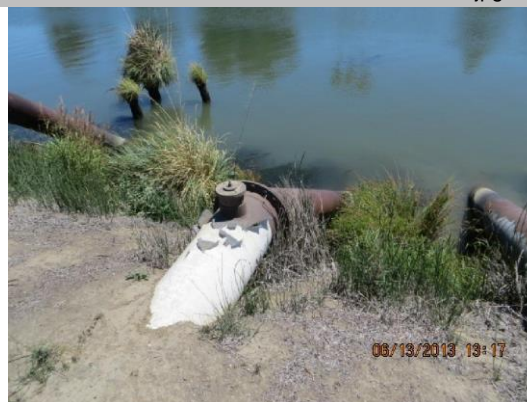
Photo 3 of 3 : UCIP_SP_2018_15027_24729.jpg

LM Start	12.00	Rating **	A/W	Issue No.	804 (cont)
LM End	12.00	Issue Type +	Ma	Location *

Pipe and siphon breaker on WS shoulder.

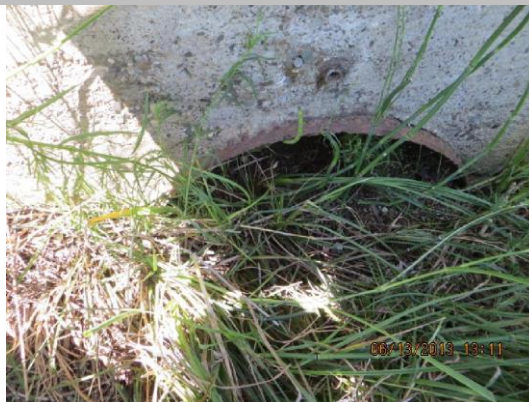
Photo 2 of 2 : UCIP_SP_2018_15028_24735.jpg

LM Start	12.00	Rating **	M	Issue No.	805
LM End	12.00	Issue Type +	Ma	Location *	
Category	Supplemental			GPS Latitude/Longitude	
				Start	End
Item	DWR UCIP LMA Responsibility			38.130730 °	38.130730 °
				-121.579616 °	-121.579616 °
DWR ID					
Comment Code					
Inspector Comment					
FS_ID:15028					
DS_ID:20182					
EP_NO: N/A					
Repair Type: Non-Urgent					
Crossing Status: Found					
UCIP Comments: Verify pipe is properly abandoned.					
FIELD_STRUCT_DESC: *REMOVED* 1 of 2: 36-inch steel drainage pipe through the levee, 4 feet below the crown. Shutoff valve at pump.					
Pipe visible on the waterside (WS) at headwall. (Replaced by a 30-inch pipe under Permit No. 2635, 1957 - Reclamation District No. 563).					
[Additional Reference(s): USACE Sacramento O&M Manual 103, June 1954, (Station ""L"" 6+39)].					
FS Date: 6/13/2013

Pipe at concrete headwall on WS slope.

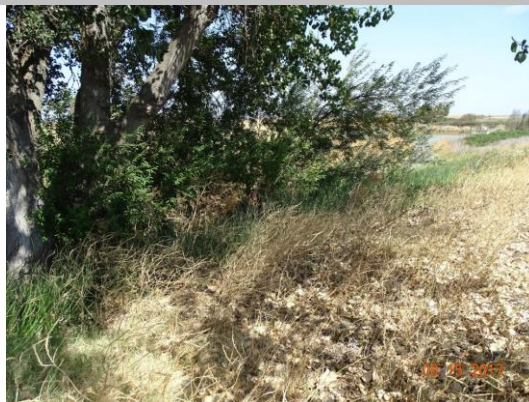
Photo 1 of 2 : SP_2018_RD0563_210_47_20180305_00035.jpg

LM Start	12.04	Rating **	M	Issue No.	47
LM End	12.04	Issue Type +	Ma	Location *	LS
Category	Earthen Levee			GPS Latitude/Longitude	
				Start	End
Item	Trim / Thin Trees			38.130758 °	38.130758 °
				-121.579027 °	-121.579027 °
DWR ID	DWR_RD0563_01_s_2012_47				
Comment Code					
T1 : Trim trees to at least five feet above ground level.					
Inspector Comment					
Trim tree on landside slope.

Looking northeast at the landside slope.
